EVALUATION OF CERAMICS FOR STATOR APPLICATIONS—GAS TURBINE ENGINES

FINAL REPORT - STATOR FABRICATION & EVALUATION

N.Arnon and W.Trela

MARCH 1983

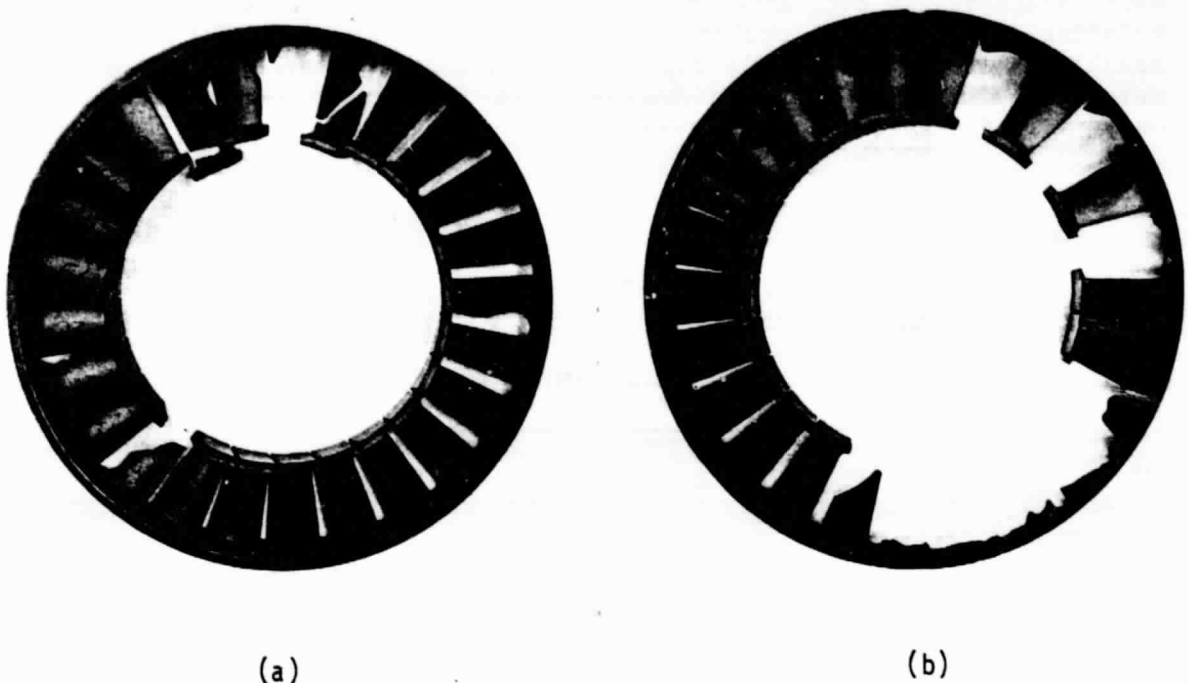
Configuration "c" was adopted after a nose cone failure, damaging both stators. The first stage stator sustained damage from both the front and rear, complicating failure analysis. The second stage stator was not actually being subjected to engine conditions because of the hot gas swirl generated by the first stage. By eliminating one stator and adjusting the rig back pressure, conditions simulating engine operation would be maintained on the first stage stator without the jeopardy of secondary damage in the event of failure. Stators from all four participants were tested in the first stage with configuration "c".

Figure 24 Stators Damaged by Nose Cone Failure: (a) Trailing Edge View of First Stage Stator. (b) Leading Edge View of Second Stage Stator

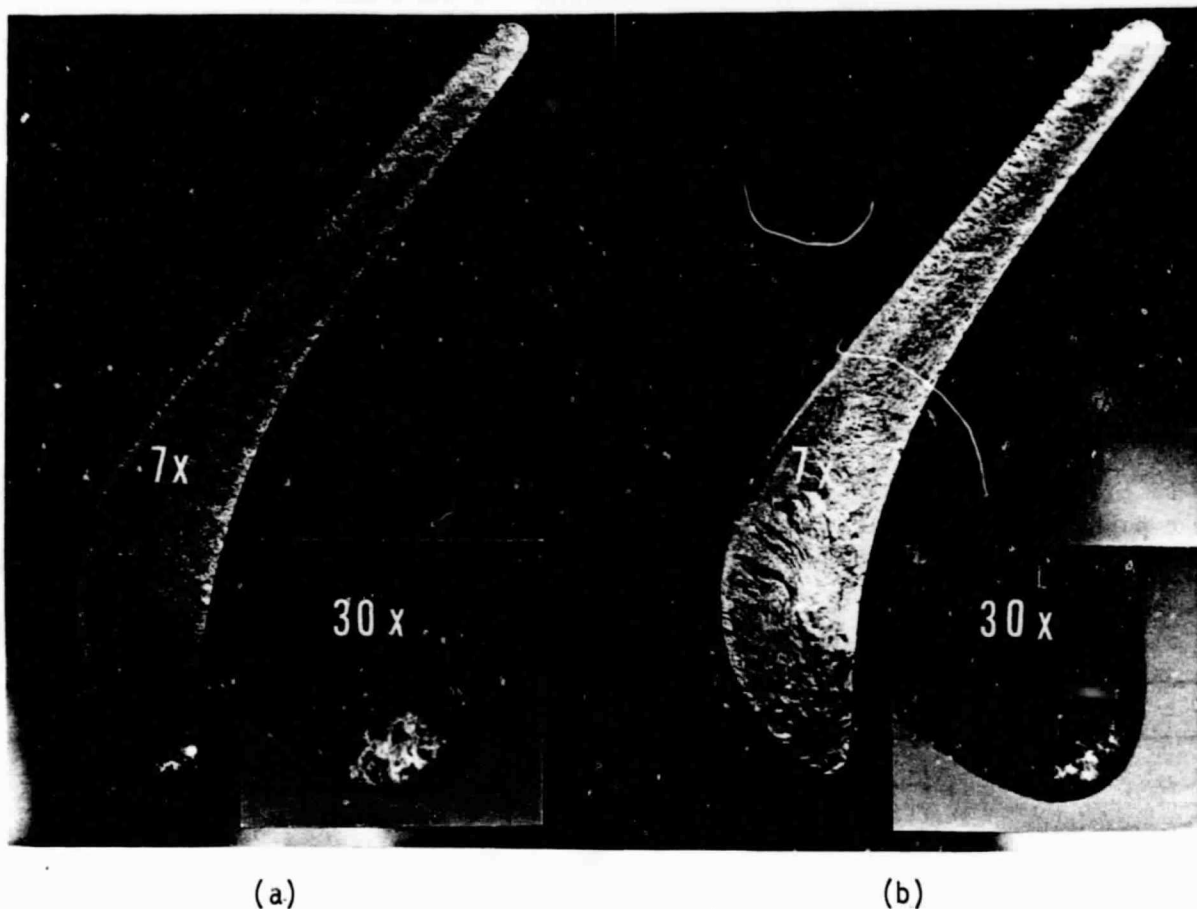
Figure 35 Typical Vane Flaws on Fracture Surface Not Observed on Vane Surface During "as-received" Visual Inspection. ACC Stator S/N 01089: (a) Vane #5; (b) Vane #19
